CHICOPEE FALLS
LOCAL PROTECTION PROJECT
SPECIAL STUDY
OF
RAILROAD EMBANKMENT

PREPARED FOR
U.S. ARMY ENGINEER DIVISION
NEW ENGLAND

OCTOBER, 1962

By
GREEN ENGINEERING AFFILIATES, INC.
BOSTON MASSACHUSETTS

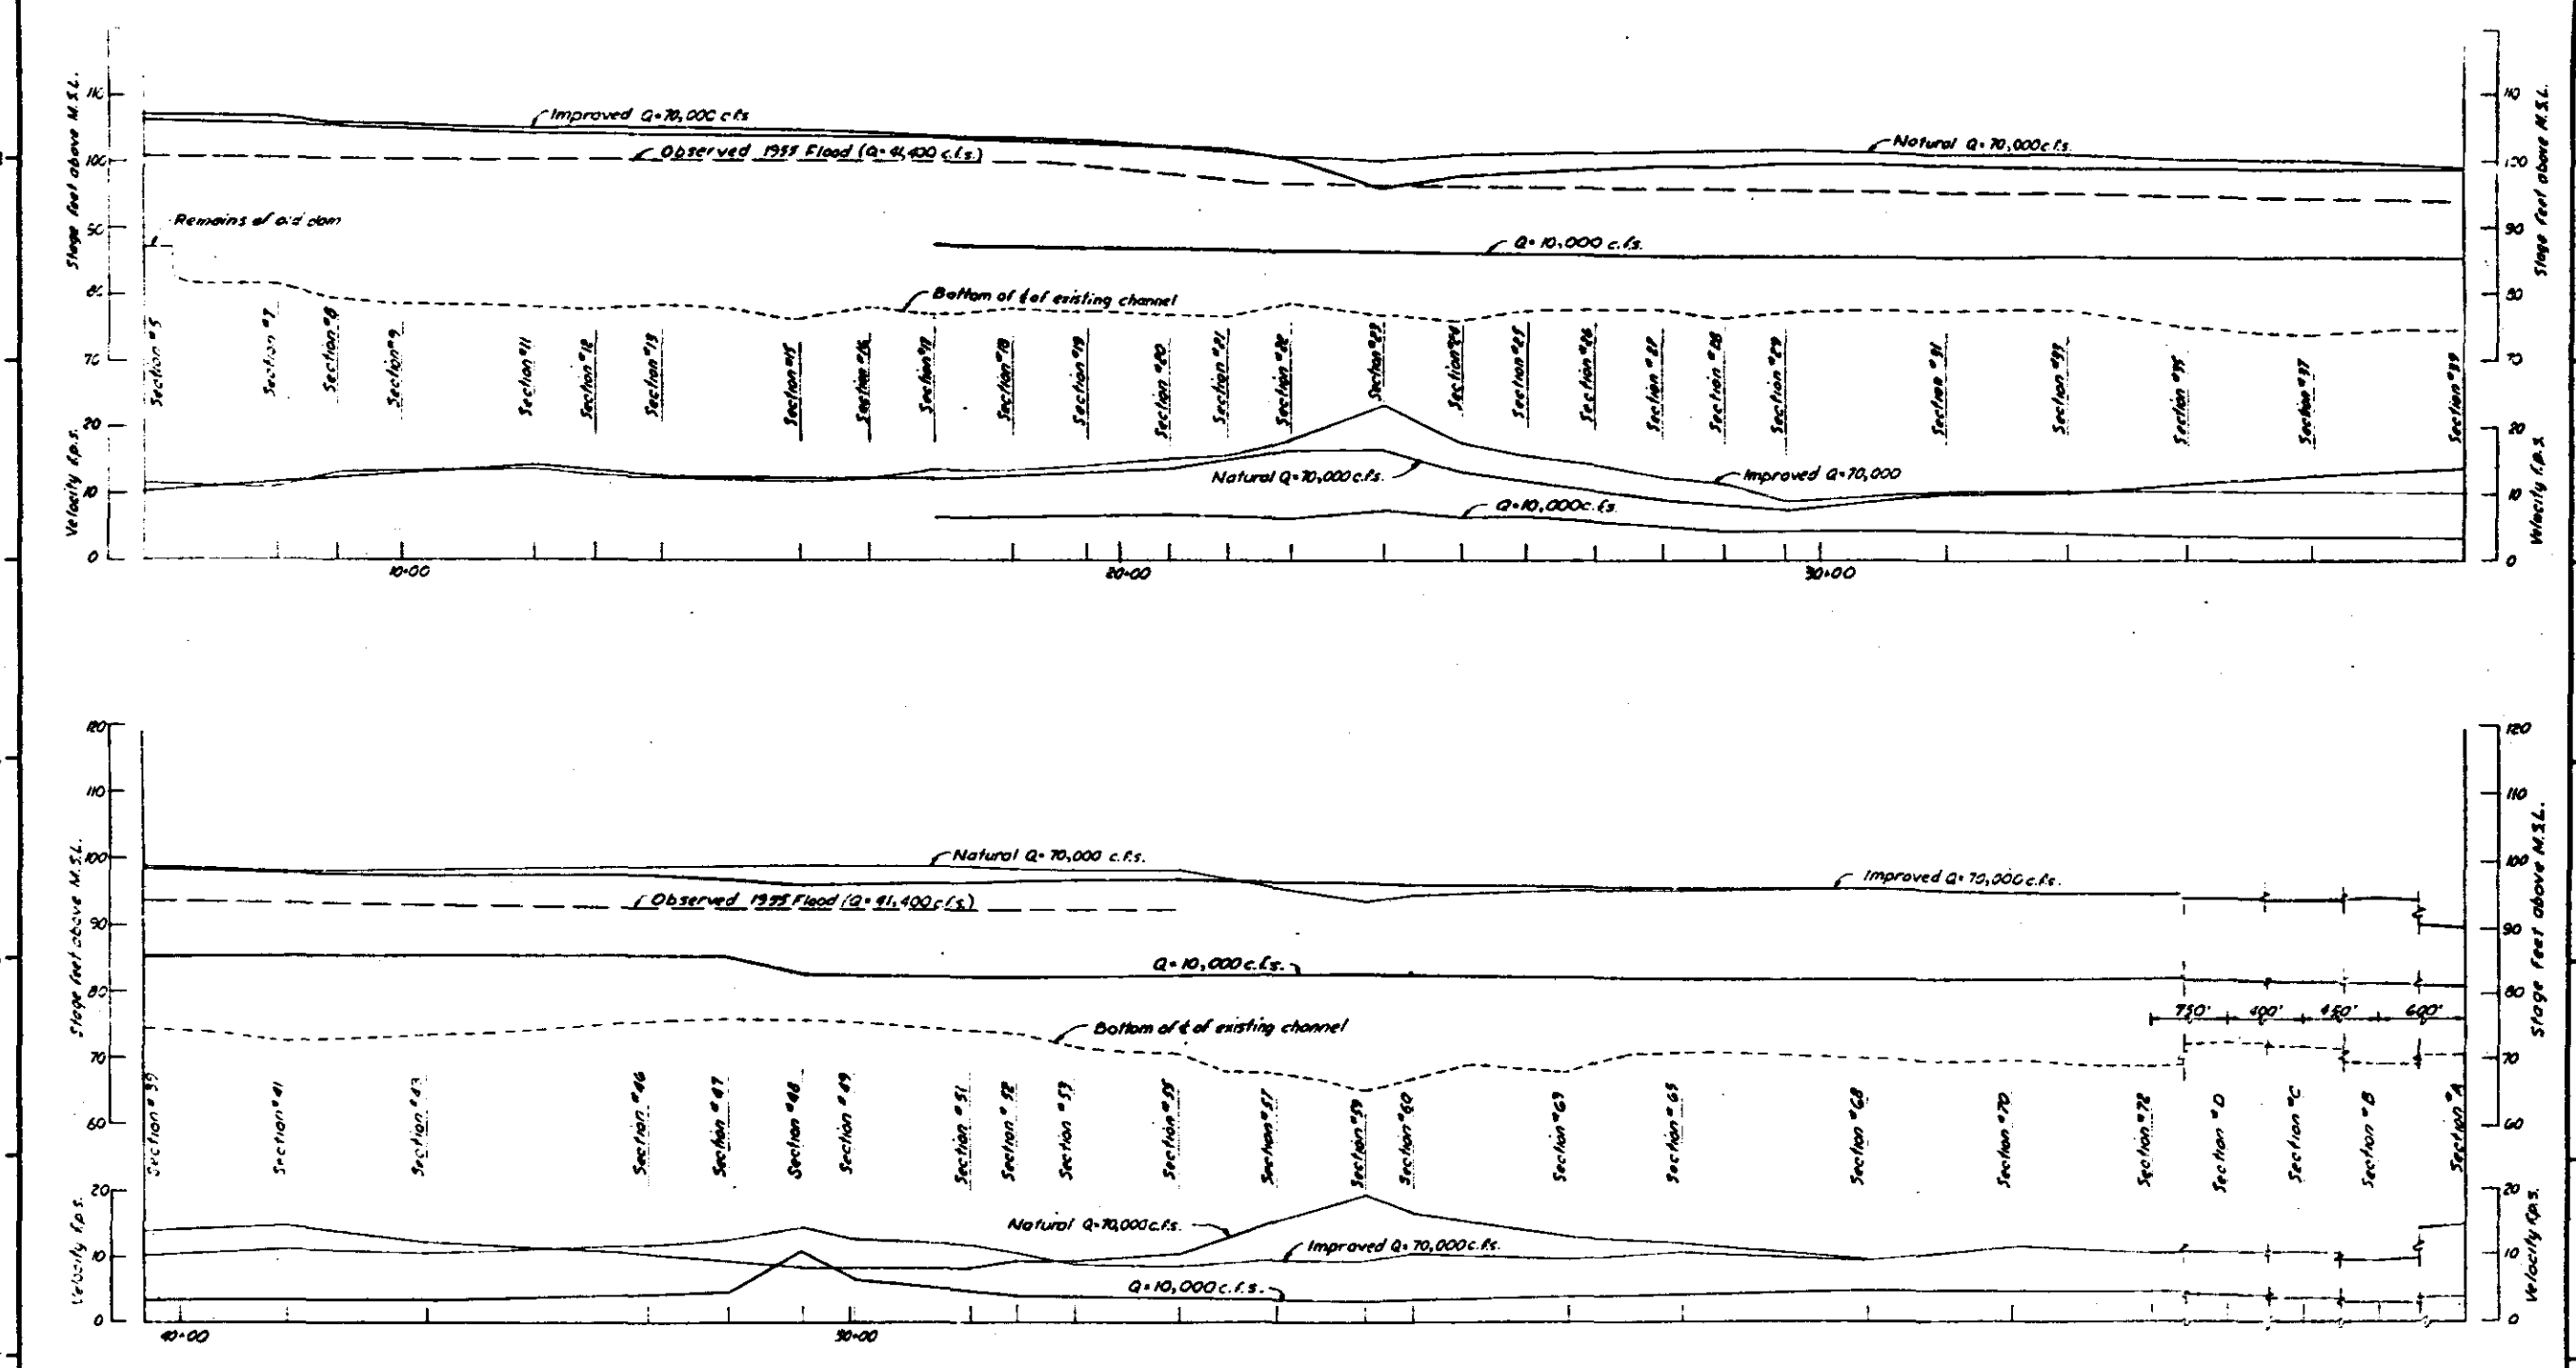
For the Project Design Flood of 70,000 c.f.s., velocities are quite high even with widening; uneven distribution would result in local velocities considerably above the average. Stages and velocities are shown on Plate 3. Protection of the embankment from erosion at the Project Design Flood would require fifteen inches of riprap on a minimum bedding of six inches of well-graded gravel. The slope should be filled out to 1 on 1.5, and erosion gulleys and scallops filled before riprapping. This work would also benefit the stability of the slopes as regards circle failures.
